# PHASE I ENVIRONMENTAL SITE ASSESSMENT

**Old Dalton Hardwood  
North Street  
(Map 215, Lot 13)  
Dalton, MA**

**November 2018**

**TRC Project No: 293334.PETRO.20001**

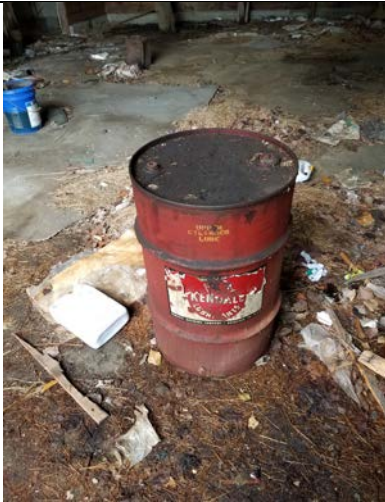
- Construction materials from former buildings;
- Tractor tires located on the Site;
- Buried and piles of metal materials; and
- Staining on the concrete garage floor near a 30-gallon drum.

Photo 3: View of a drum located in the garage labeled "Upper Cylinder Lube", with a minimal amount of liquid remaining; staining is visible on the concrete floor.

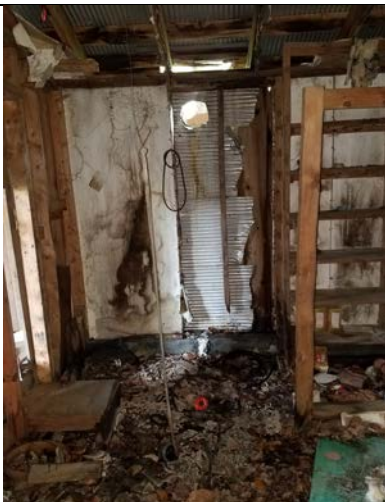
Photo 5: View of possible furnace room in the garage. The hole in the wall near the ceiling appeared to connect to an exterior cinder block chimney.

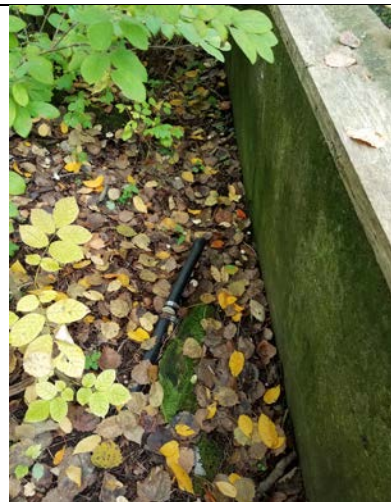
Photo 6: View of a plastic pipe outside the foundation of a former house located adjacent to the garage.

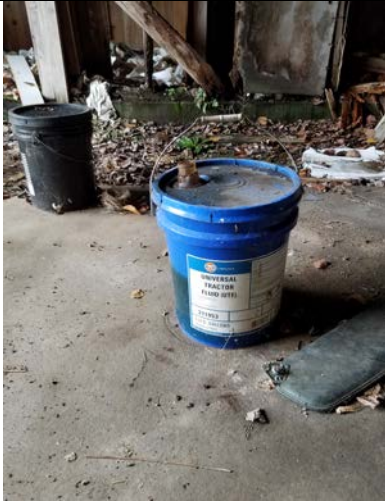
Photo 7: View of a 5-gallon bucket half full of Universal Tractor Fluid in the garage. No staining observed.

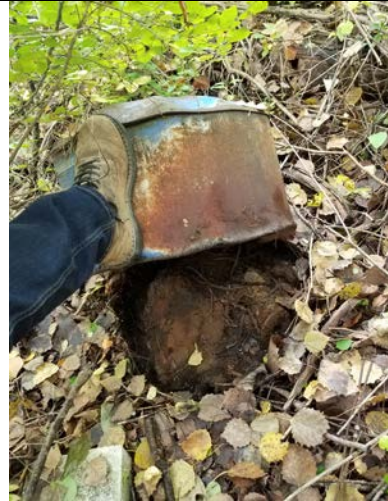
Photo 8: View of metal debris discarded on Site.

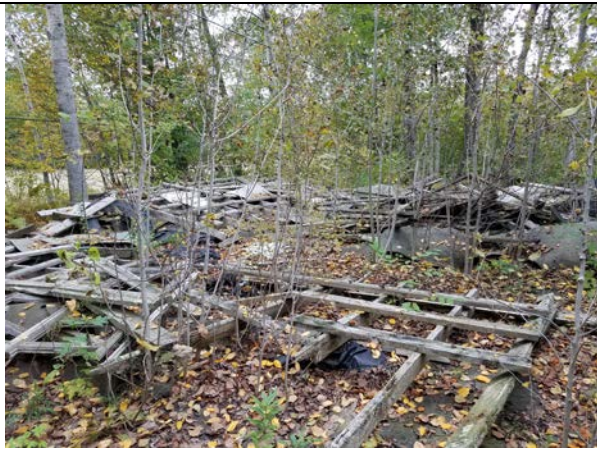
Photo 9: View of a former house adjacent to the garage to the north; construction materials and foundations are visible.

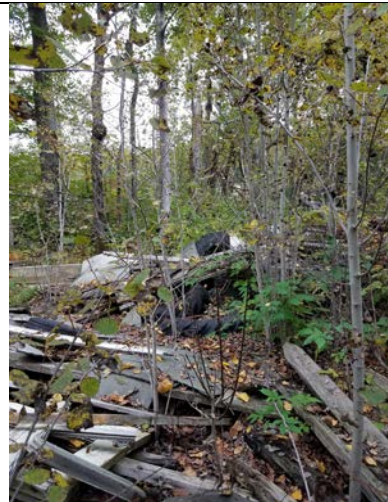
Photo 10: View of construction debris and tractor tires on the Site.

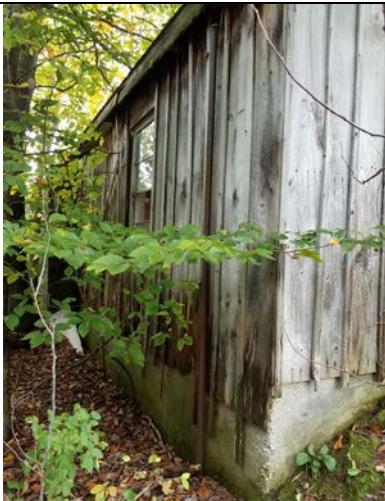
TRC observed a vent pipe near the southeastern corner of the garage running up alongside the exterior garage wall which may be indicative of an existing UST in the area. The UST may be located in front of the garage near the southeast corner of the building due to the lack of large trees in this area as opposed to along the southern wall of the garage. No fill port was found. No additional information was reviewed to indicate the size; contents or age of the UST but is suspected of being a former fuel oil UST to heat the garage (and possibly the adjacent home).

During the Site visit, TRC observed a vent pipe along the southeast corner of the garage on the Site. TRC believes a UST may be present near this location, possibly located in front of the garage near the southeast corner of the building due to the lack of large trees in this area. No additional information was reviewed that indicated the contents, size, or age of this suspected UST. The potential exists for the assumed contents of petroleum in the UST may have impacted the subsurface conditions at the Site which would constitute a REC.

Photo 11: View of the southeast corner of the garage and a suspected vent pipe.

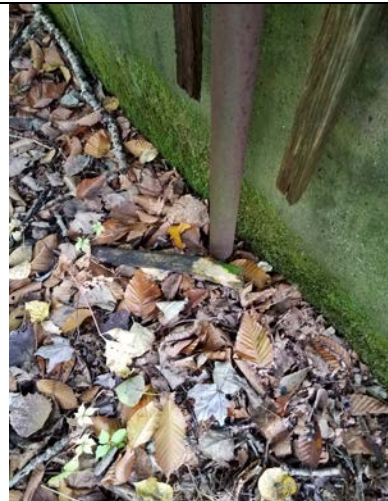
Photo 12: View of the suspected vent pipe visible coming from the ground.

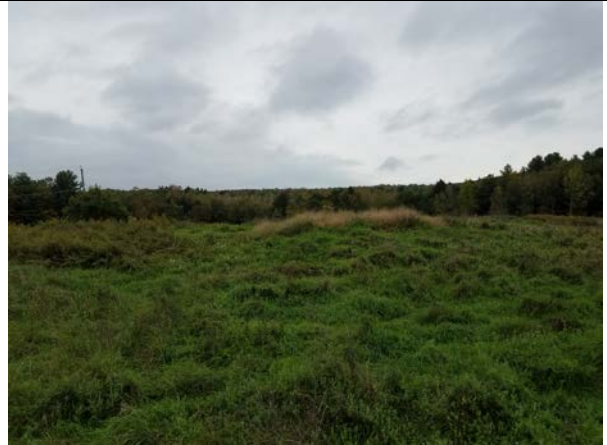
Photo 14: View of the area the Town did excavated a test pit in the central portion of the Site. The vegetation appears discolored.

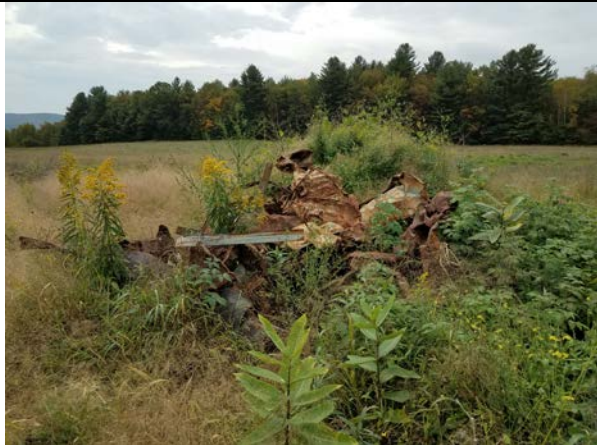
Photo 17: A pile of metal debris unearthed during the test pit the Town excavated in the central-portion of the Site in the summer 2018.

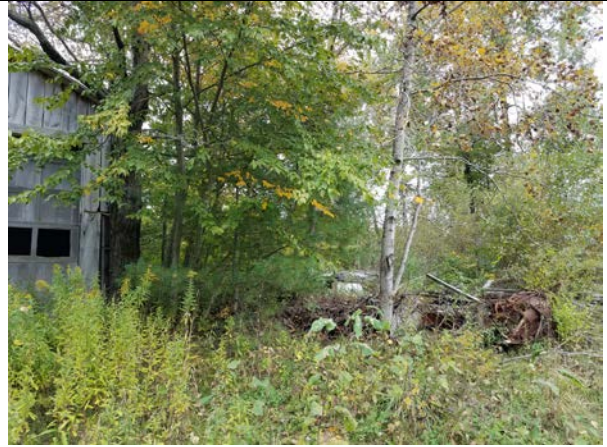
Photo 20: View of a pile of construction debris from the former house and a pile of metal parts.

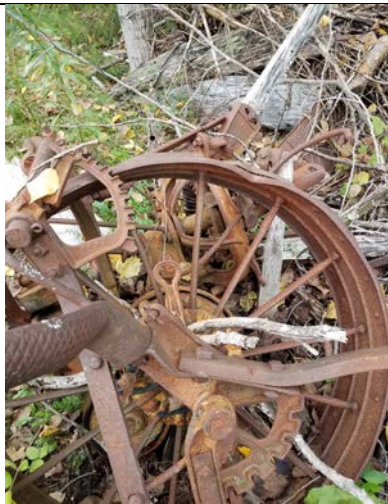
Photo 23: View of a pile of metal parts.

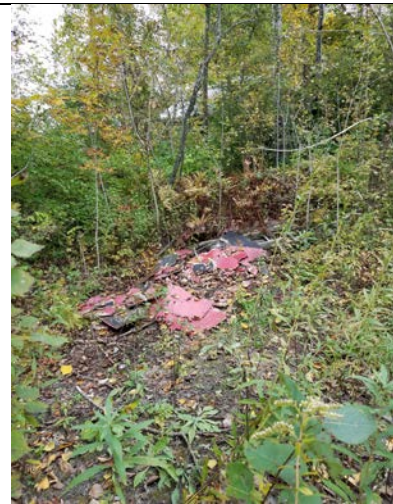
Photo 24: View of the remnants of a third former structure (possible outbuilding/storage shed) located to the south of the garage.
