# INDOOR AIR QUALITY ASSESSMENT

**Dalton Police Department  
462 Main St., Ste 7  
Dalton, MA**

Prepared by:  
Massachusetts Department of Public Health  
Bureau of Climate and Environmental Health  
Indoor Air Quality Program  
June 2024

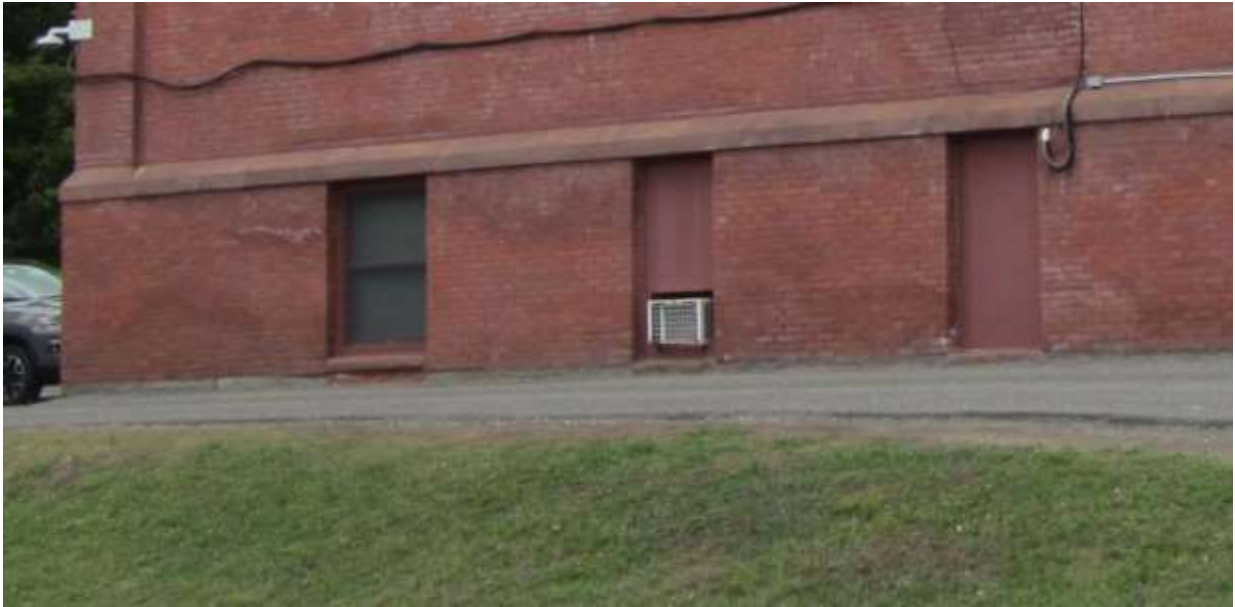
**Picture 1**

To provide cooling, some areas have window mounted air-conditioners (WACs) in ground level windows (Pictures 1 and 2). WACs recirculate air in a room, but do not provide significant fresh air. One portable WAC was found on a filing cabinet (Picture 3). As WACs operate, condensation accumulates on the cooling coils which should be drained. In this instance, overflow has corroded the file cabinet (Picture 4), possibly wetting important files.

**Permanently installed window air conditioner**

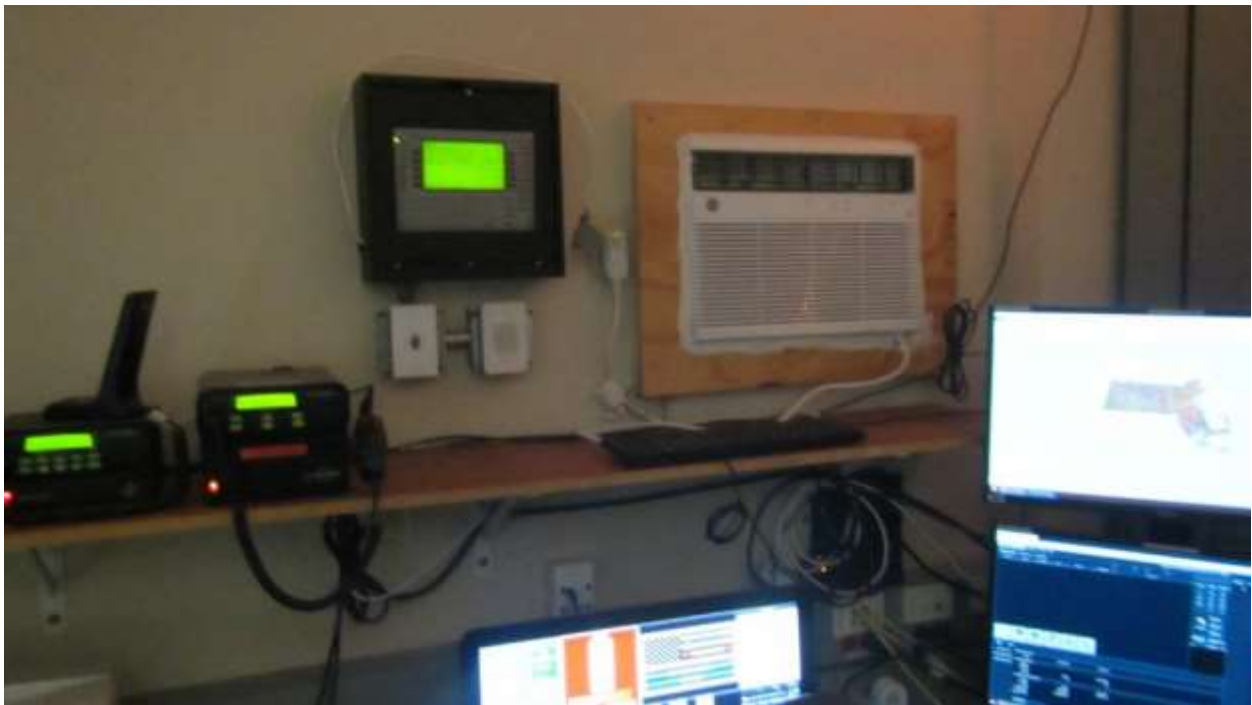
**Picture 2**

**Window air conditioner - interior side of Picture 1**

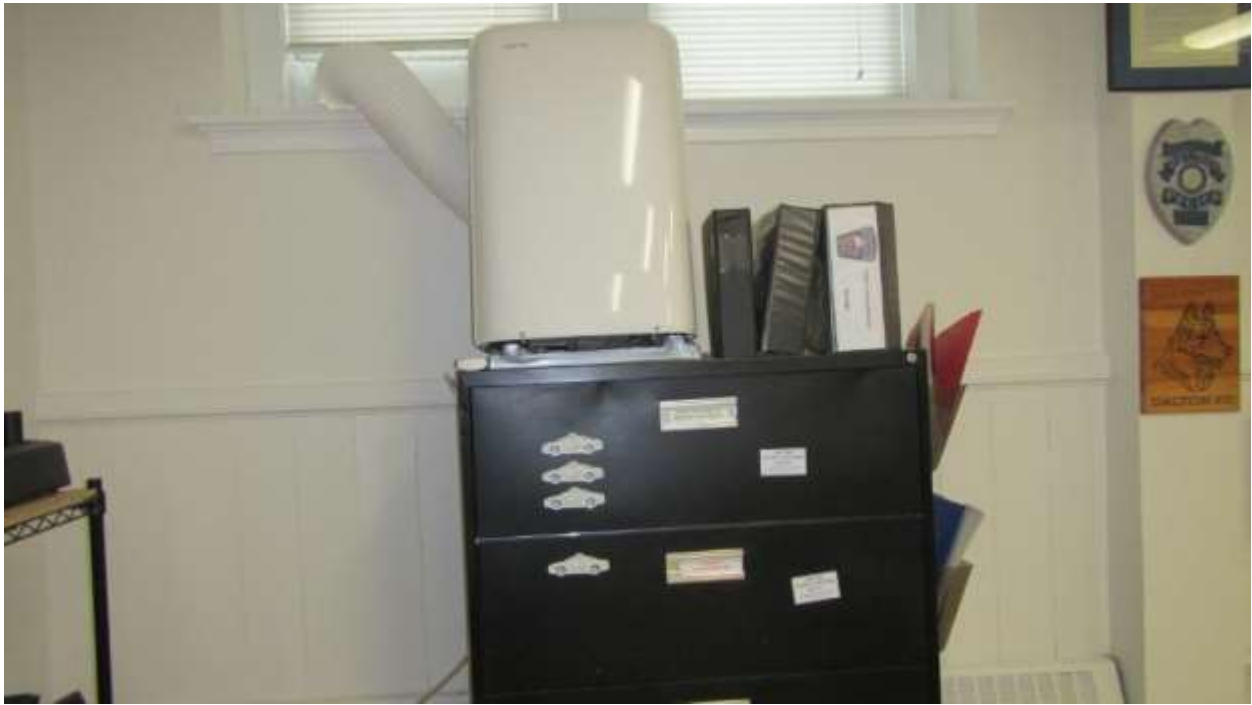
**Picture 3**

**Portable air-conditioner balanced on top of file cabinet**

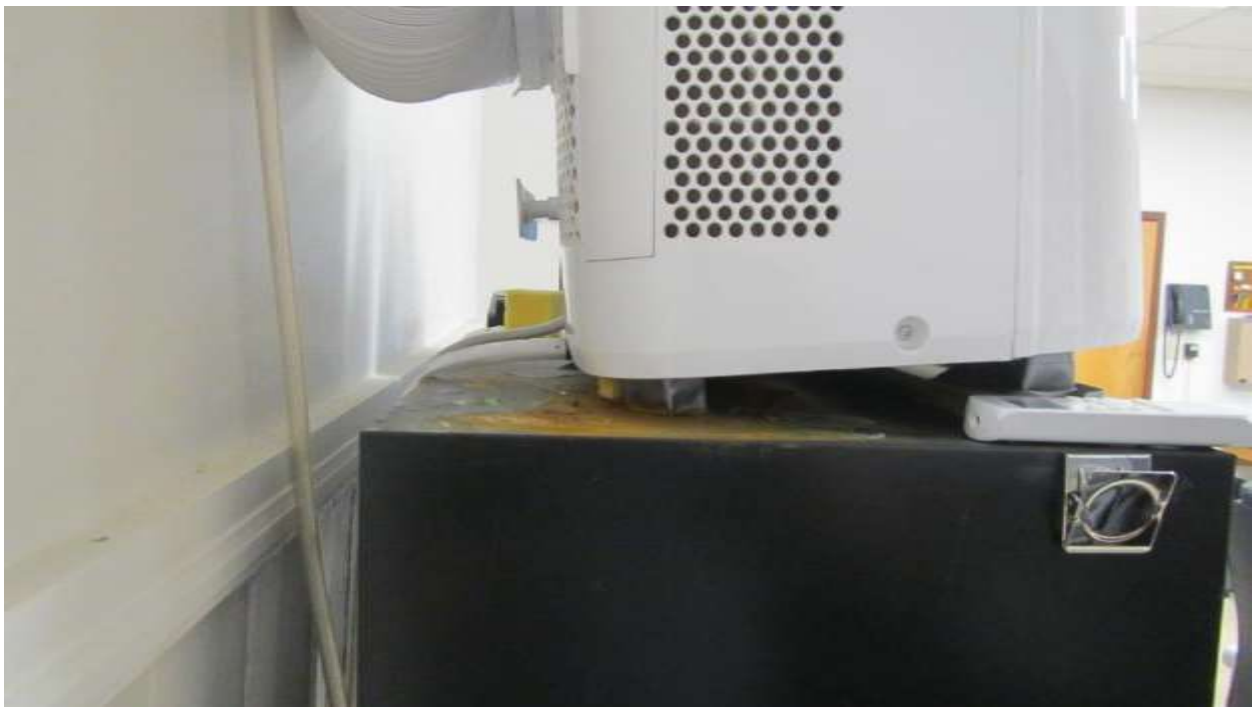
**Picture 4**

**Cabinet corrosion from condensation overflow of portable air-conditioner in Picture 3**

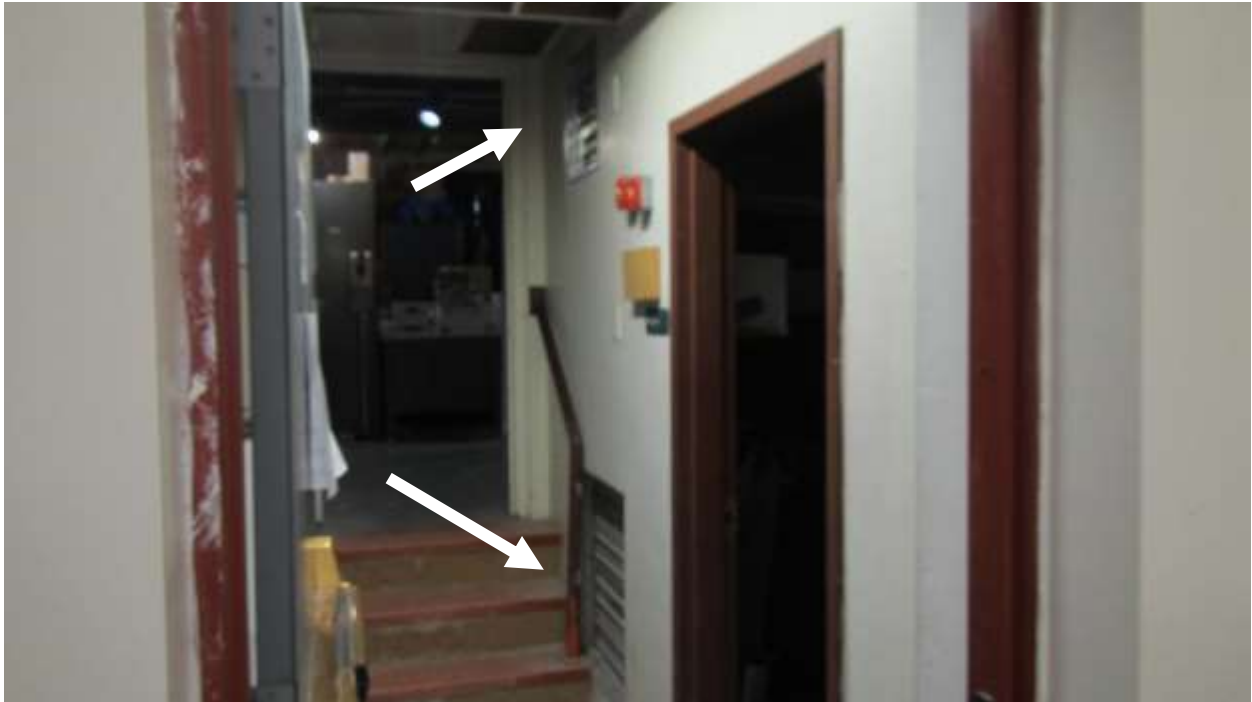
**Picture 5**

The DPD is immediately adjacent to the furnace room of the building. An examination of the furnace room interior found no source of outdoor combustion air. A set of louvered vents were found in the hallway interior wall (Picture 5), which appear to open and close when the furnace is activated, indicating that combustion air is drawn from the basement indoor air. To properly combust fuel, an outdoor source of oxygen is needed. Without an adequate fresh air supply, combustion of fuel may not proceed completely, leading to excess products of combustion being formed, including carbon monoxide. The louvered vents and the door may also allow products of combustion and fuel odors into the basement and DPD occupied space.

**Louvers in furnace room hallways**

1. Install a combustion air vent in the furnace room to allow for the furnace to properly combust fuel and to properly vent combustion products from the furnace room. The air vent should draw outdoor air. Once installed, permanently seal the hallway wall vent in Picture 5.
2. When operating, areas that have window-mounted air conditioners should have hallway doors closed.
3. Install a wall-mounted carbon monoxide detector with digital readout capabilities in the DPD.

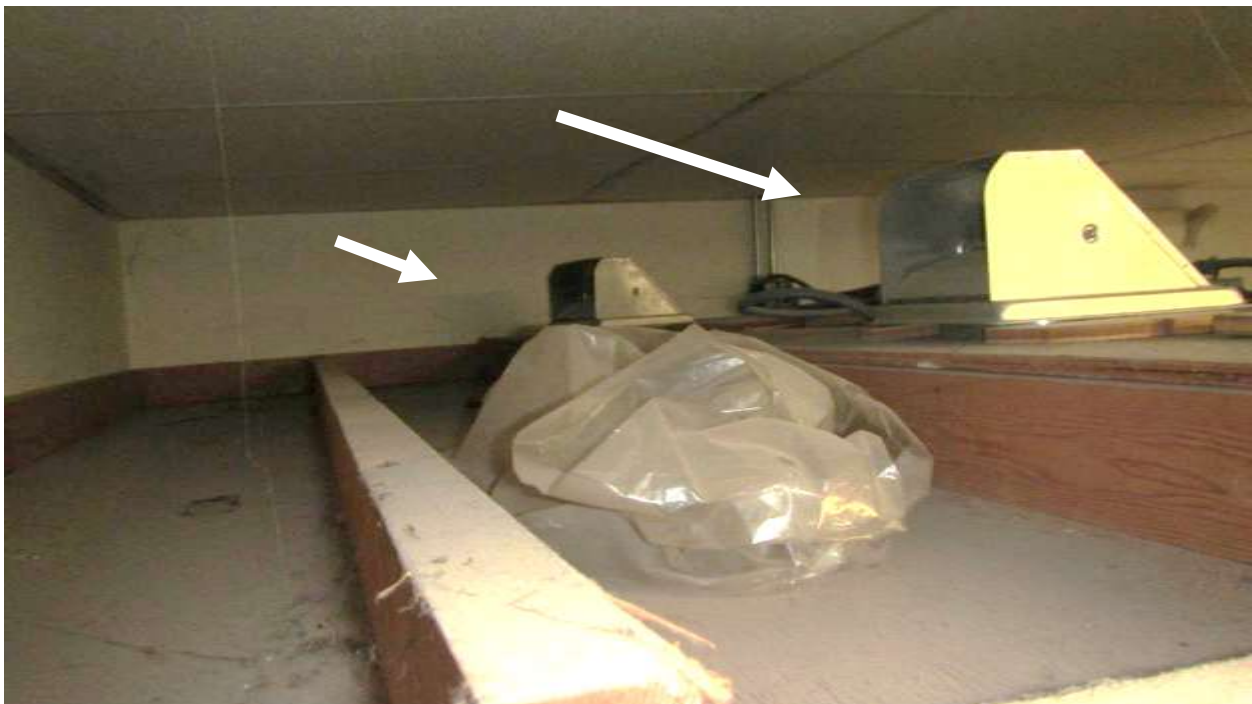
**Picture 6**

The DPD contains holding areas that have exhaust fans installed in the ceiling of cells (Picture 6). These exhaust fans are not directly ducted to the outdoors and only eject air from the holding cells, which is then drawn back into the cells from the room. Exhaust ventilation fans should be connected to ductwork with a terminus outdoors to eject water vapor and odors from the building.

**Exhaust vent for cells, note no ductwork connected to outdoor vent**

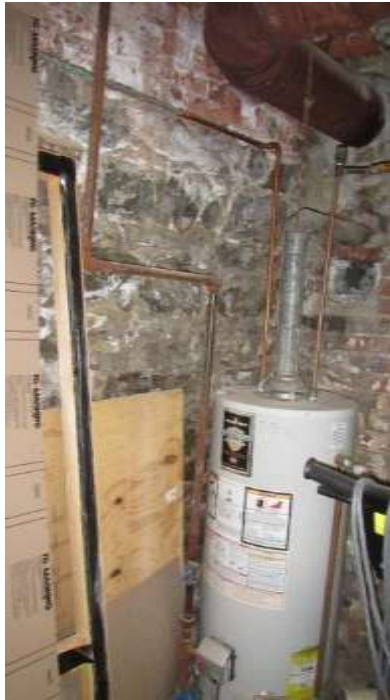
**Picture 7**

**Furnace room with brick-and-mortar interior wall shared by DPD office with damaged wainscoting**

3. Consideration should be given to removing water-damaged wainscoting in a manner consistent with the US EPA guidelines, Mold Remediation in Schools and Commercial Buildings.

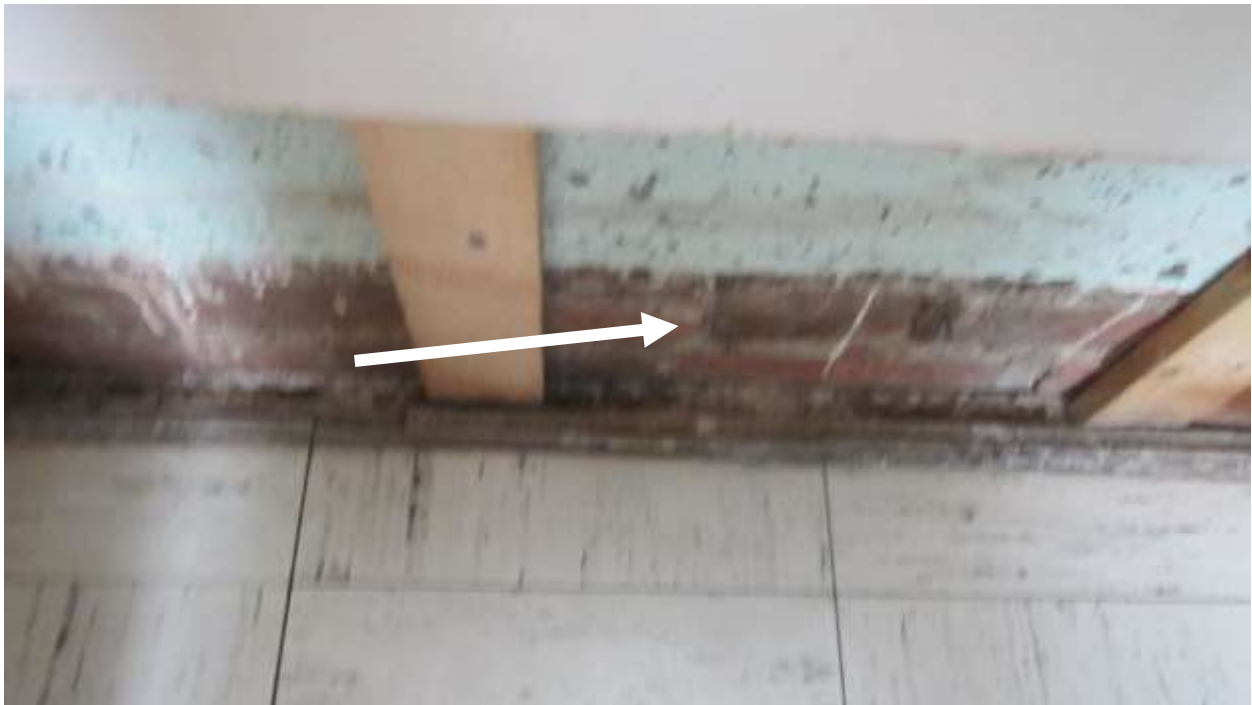
**Picture 8**

Several signs of water damage exist in the DPD space independent of the reported sewer backup experience in the DPD restroom. Some unfinished areas appear to have foundation walls made of brick and mortar (Pictures 8 and 9). Brick and mortar are water-permeable materials that can allow rainwater to migrate into the basement. Several DPD rooms have wooden wainscoting installed along the base of basement offices. The wainscoting appears to be made of individual strips of tongue-in-groove wood. Seams of the wainscoting also appear to be warped and cracked (Picture 9), which may occur when tongue-in-groove wood is exposed to excess moisture such as water infiltrating brick and mortar. Repeated exposure to moisture can cause wood to become mold-colonized. Sources of water damage likely include:

**Base of foundation wall in flooded restroom consists of brick and mortar to the floor**

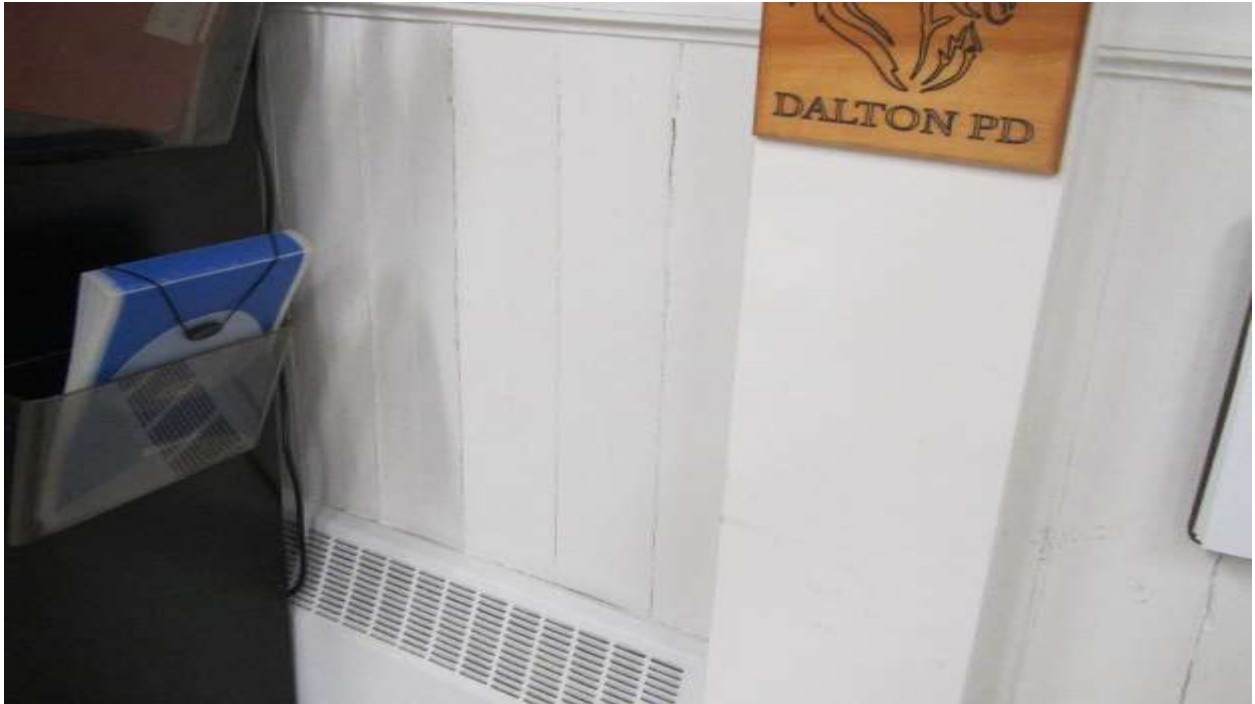
**Picture 9**

**Warped wainscoting, indicating possible water penetration through foundation wall**

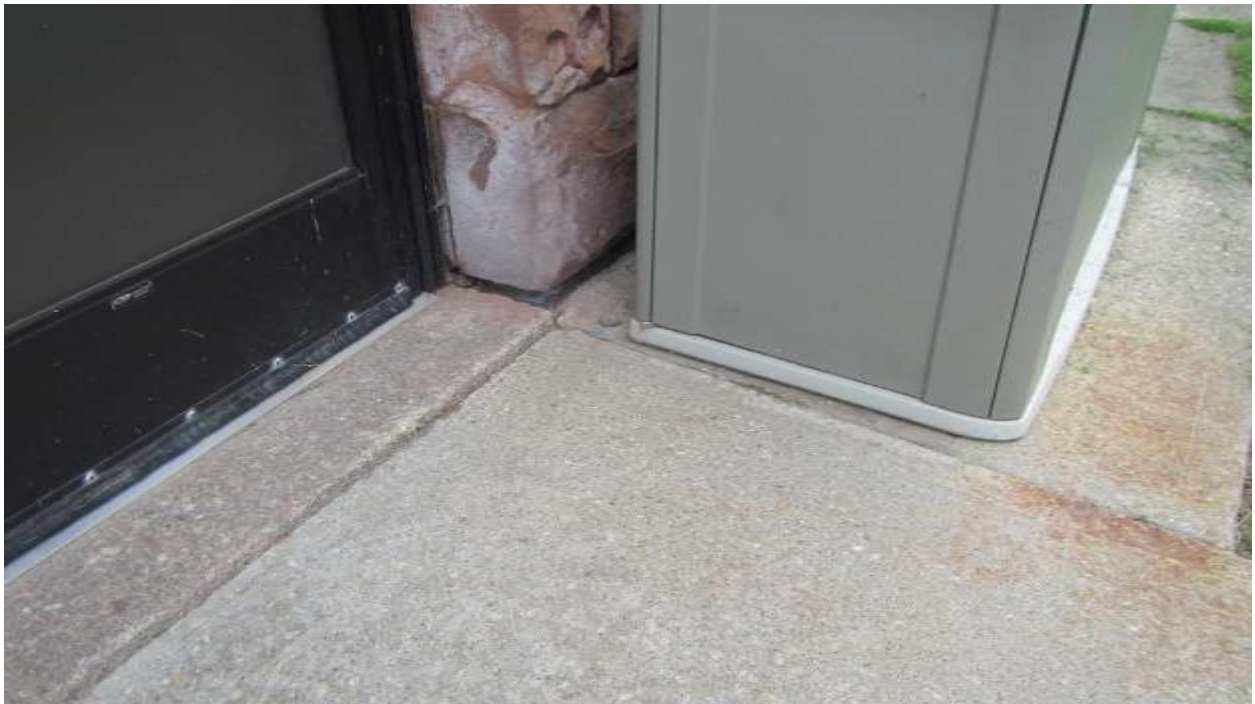
**Picture 10**

**Gap between sidewalk and foundation wall where water can accumulate**

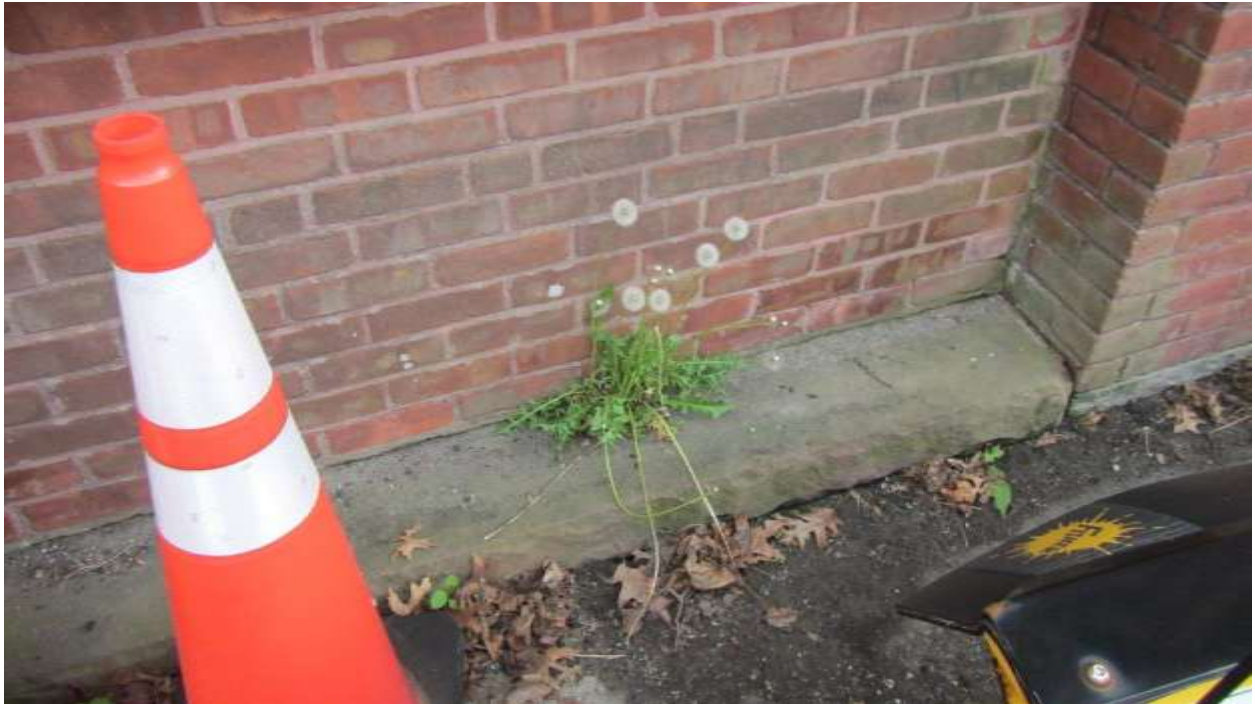
**Picture 11**

**Gap between the foundation and tarmac, also space in sill and brick joint**

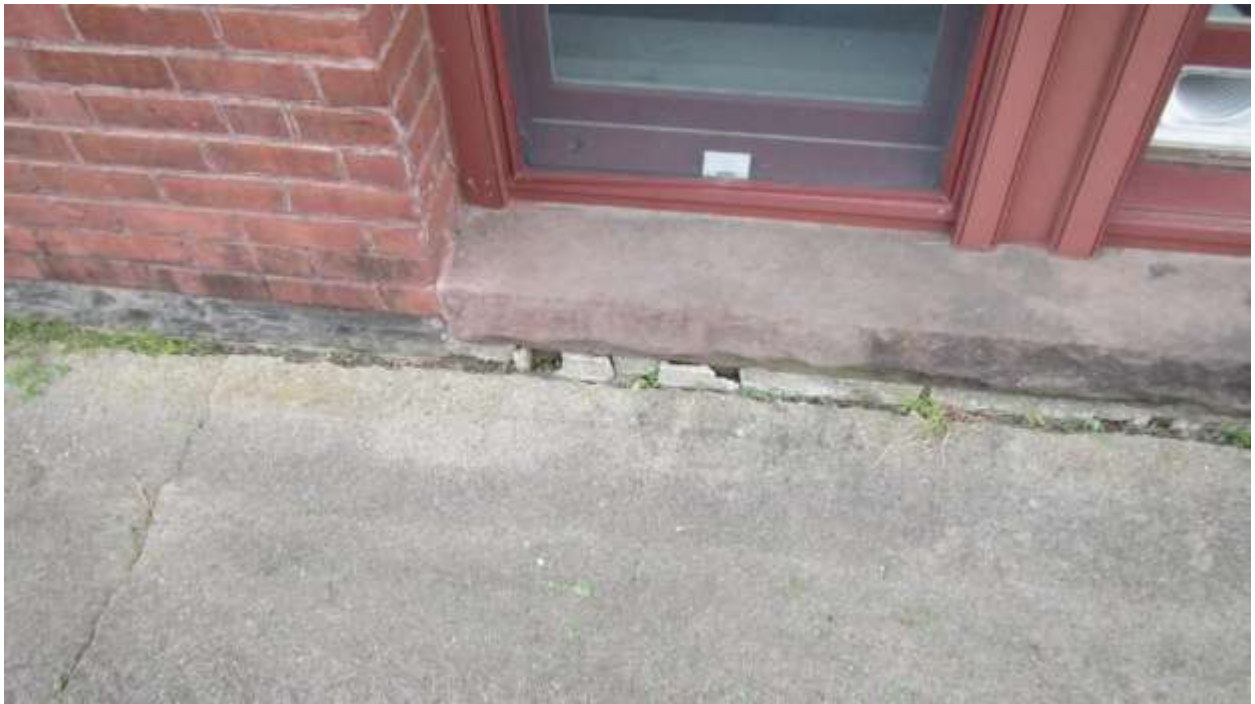
**Picture 12**

**Gap between cement apron and basement windowsill**

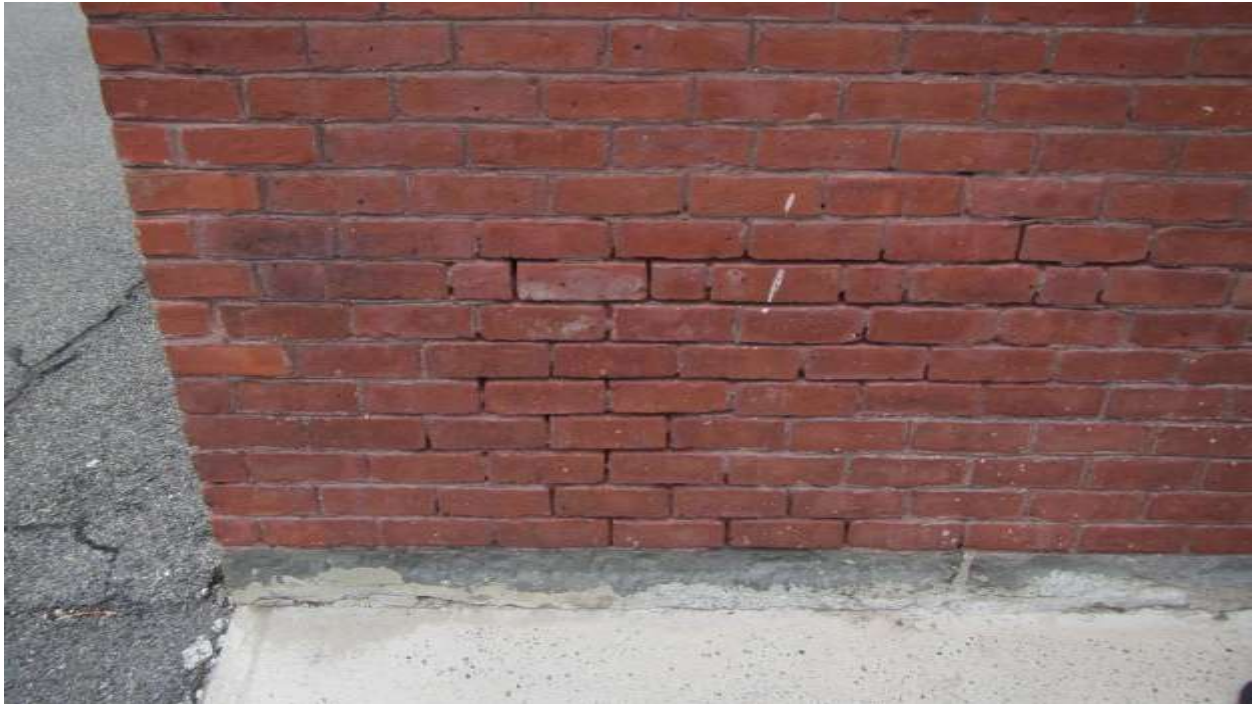
**Picture 13**

**Missing mortar between exterior wall bricks**

4. Repoint brickwork with missing/damaged mortar in exterior walls.
5. Remove plants and reseal junction sidewalk and building foundation.
6. Reset the apron to minimize space between cement blocks and to ensure continuous drainage from roof.
7. Replace missing downspouts from roof gutter system.
8. Eliminate space between window-mounted air conditioner on outside of building.

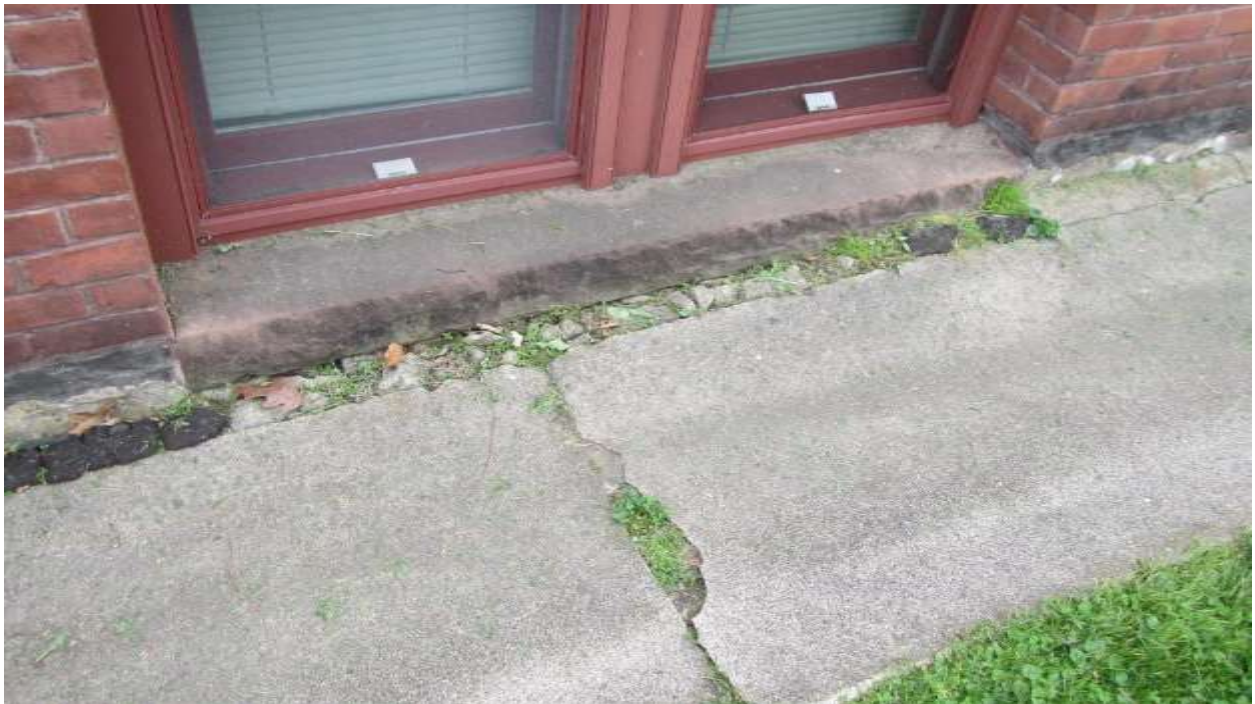
**Picture 14**

**Seams in cement apron exposing soil to become moist from rain  
Note plant growth between cement slabs of apron as well as the windowsill and apron**

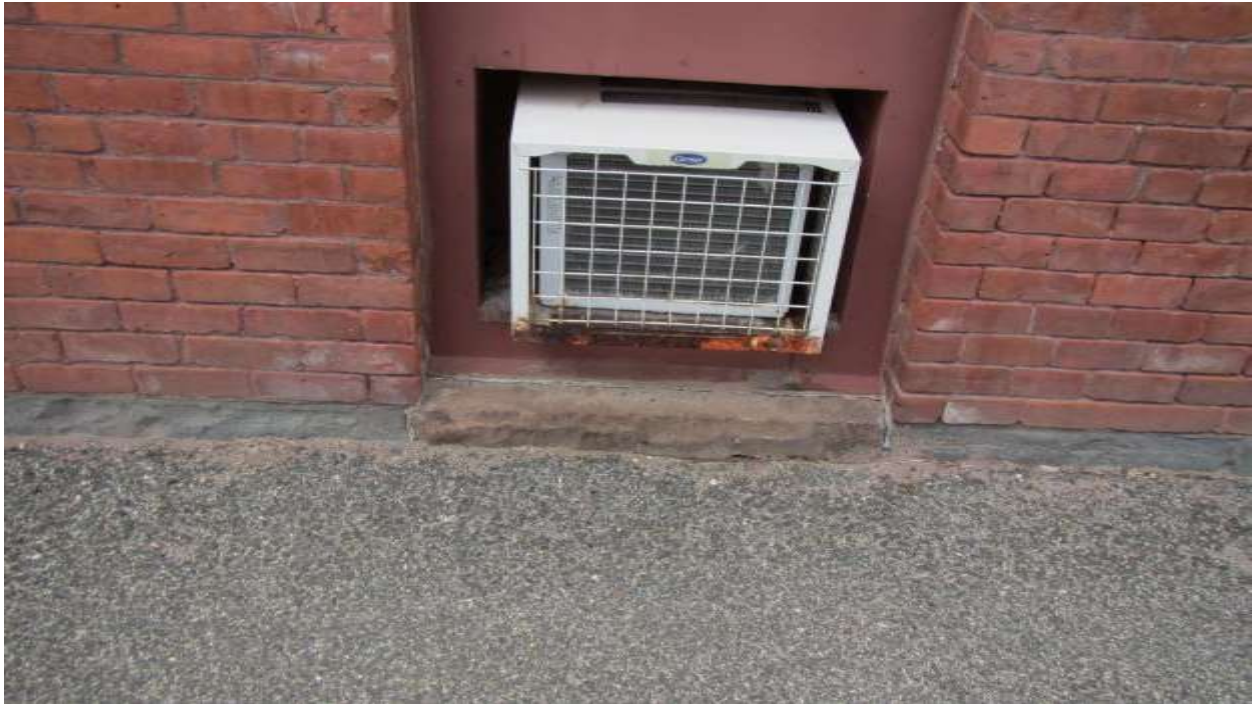
**Picture 15**

**Spaces around WAC installation, note opening larger than size of installed window-mounted air-conditioner, which can allow for rainwater to moisten wood**

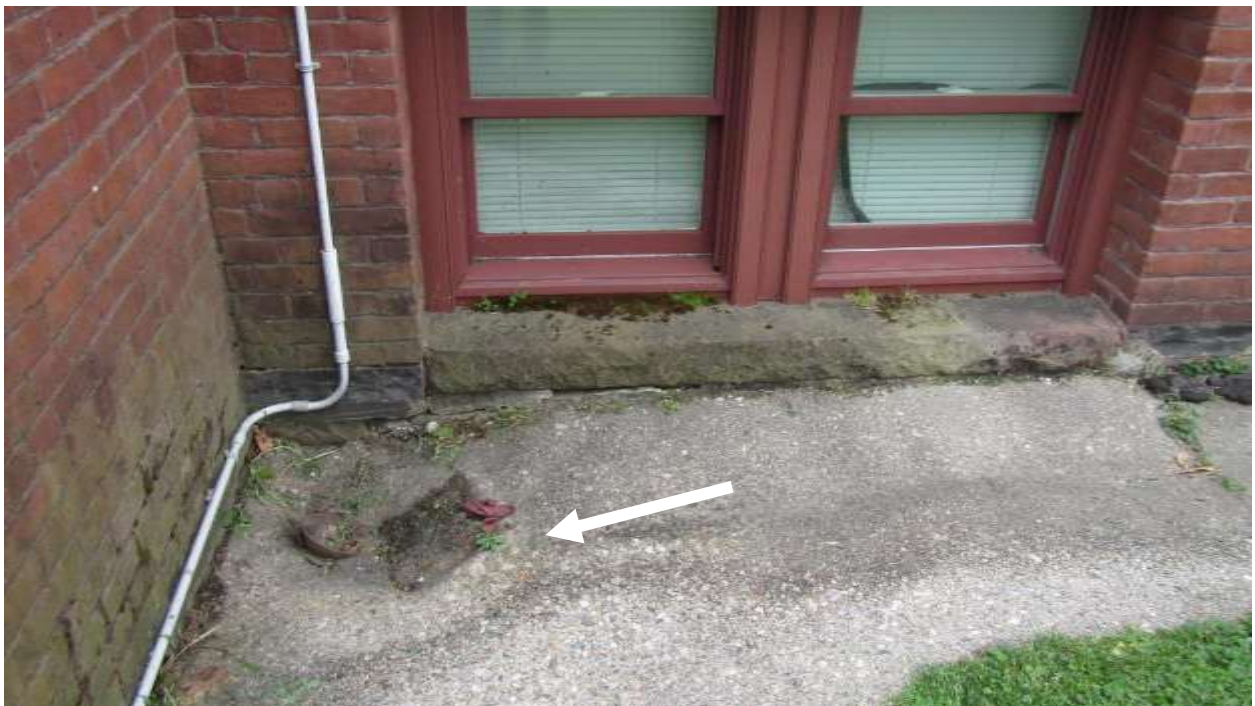
**Picture 16**

Of note is the remnants of a downspout system (Picture 16). These downspouts likely emptied onto the cement apron at the base of the foundation, which in turn drained at the location in the corner of the building (Picture 16). Drained rainwater directly impacting the apron can damage the cement, cause the cement blocks to settle which disrupts water flow to the drain and opens spaces for water to penetrate beneath the apron to expose the foundation to moisture. Once water accumulates against the foundation, moisture can then migrate through seams in the foundation wall to moisten building components, including the wainscoting. To prevent moisture penetration through foundation walls, it is important to limit the ability of rainwater to penetrate below the foundation between the junction of the sidewalk and the exterior wall of the building.

**Possible remnants of a downspout system in cement apron**

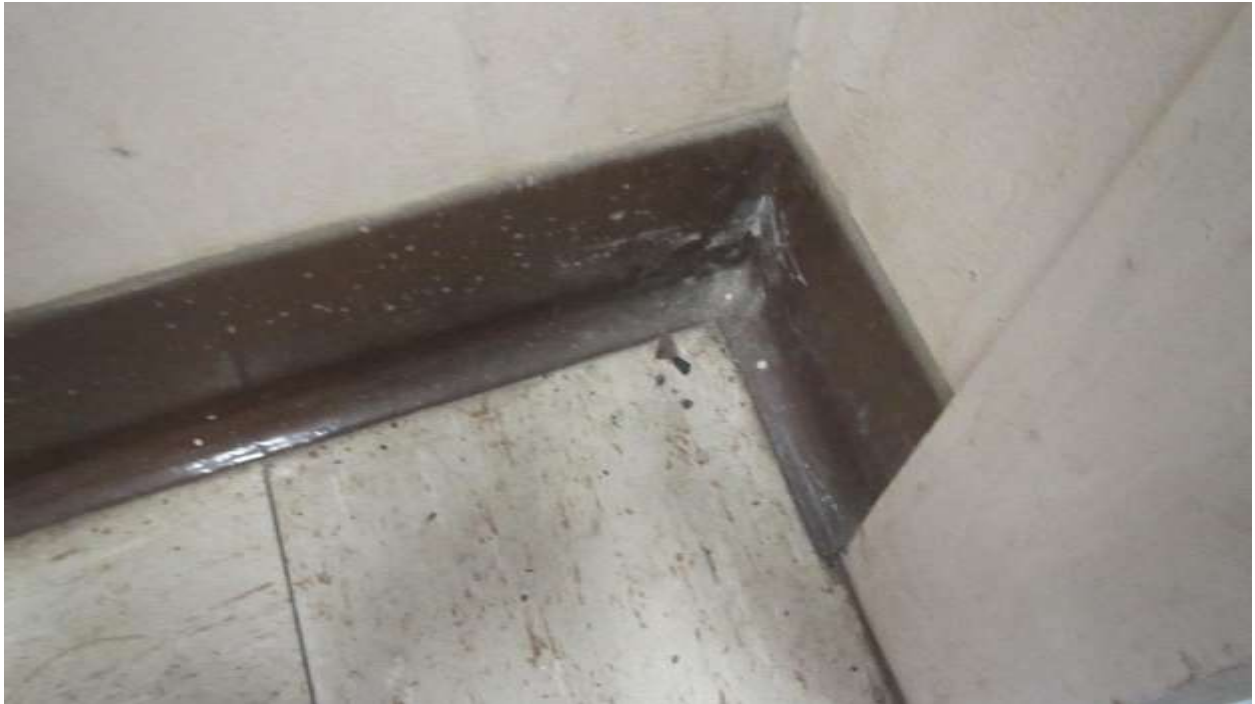
**Picture 17**

Rodent droppings were noted in the main hallway (Picture 17). DPD staff reported rodent sightings after the flood of the restroom detailed in the water damage report (Appendix 1). Rodent infestation can result in IAQ related symptoms due to materials in their wastes (USEPA, 2024). Mouse urine contains a protein that is a known sensitizer (USEPA, 1992). A sensitizer is a material that can produce symptoms (e.g., running nose or skin rashes) in sensitive individuals after repeated exposure. A three-step approach is necessary to eliminate rodent infestation:

**Rodent droppings in main hallway**

14. Use Integrated Pest Management (IPM) to remove pests from the building. A copy of the IPM recommendations can be downloaded from:  
<https://massnrc.org/ipm/docs/ipmkitforbuildingmanagers.pdf>. Activities that can be used to eliminate pest infestation may include the following:

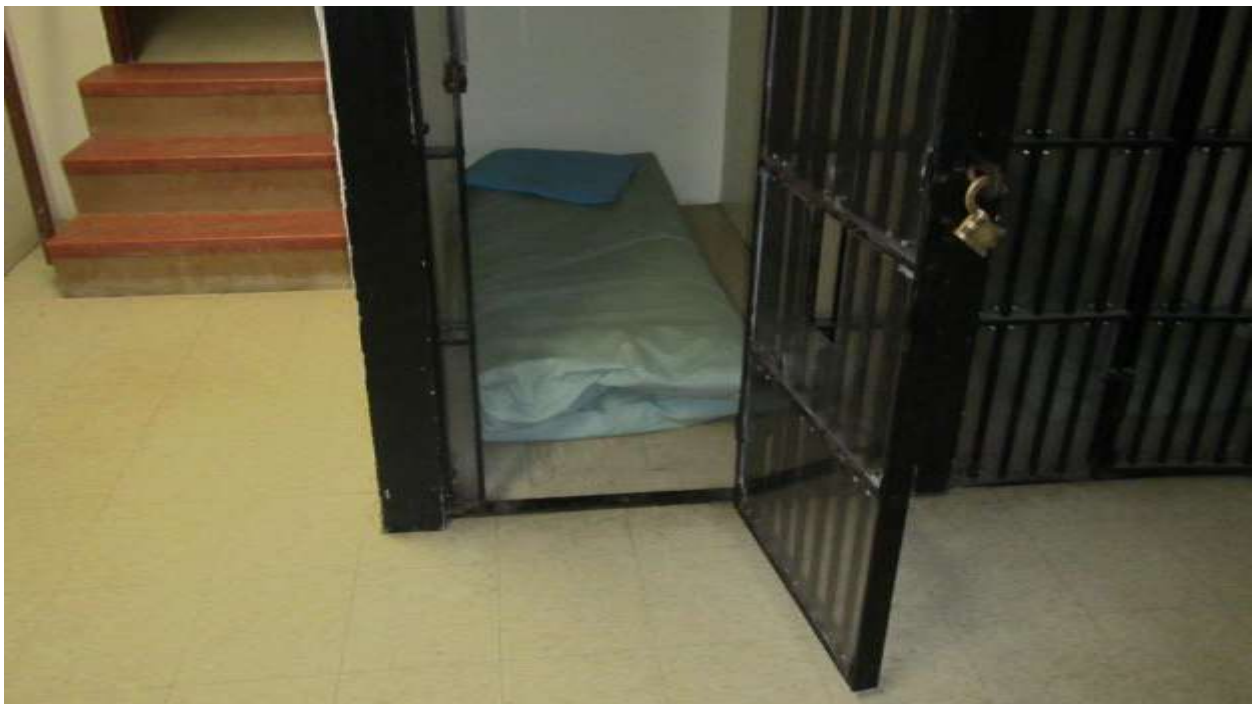
**Picture 18**

Lockup cells (Picture 18) were examined for signs of mold growth or related odors. No visible mold growth or odors were observed however, the following conditions were found in the holding cells:

- Holding cells had walls/ceilings susceptible to mold growth. The walls and ceilings are constructed of gypsum wallboard which can grow mold if moistened and not dried soon enough.
- As previously noted, holding cells do not have ducted exhaust ventilation.
- Holding cells have no sink or toilet facilities.

**Holding cells with gypsum wallboard walls**

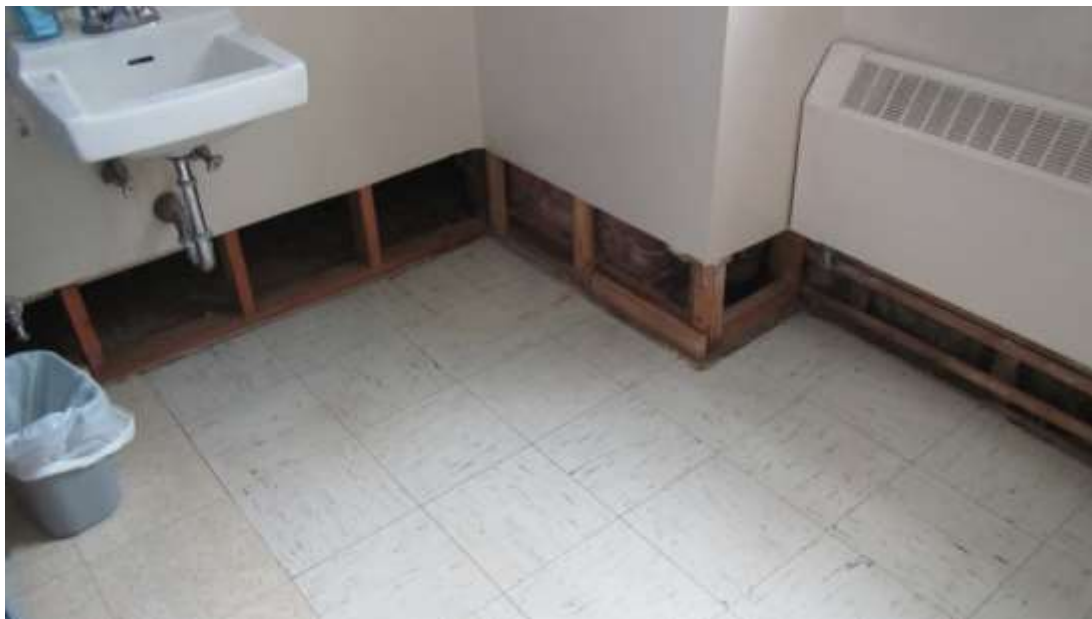
**Picture 1**

floors: the flooded restroom, adjacent hallway and dispatch office. The moisture measurements showed that the underflooring beneath the tile was saturated (Picture 1) with black water in the restroom, hallway and part of the dispatch flooring. The moisture measurements also indicated the underlying flooring was wet for more than 11 days (240+ hours) since the last flooding incident. It is likely that the black water remains in the space between the flooring and the cement floor of the basement.

**Removed GW wetted by flooding**

2. Ensure that all porous items and building materials (e.g., engineered wood, GW) that were damaged by the backup of blackwater are removed and discarded. This would include wall studs in restroom wall cavity if deemed porous and not able to be properly sanitized.

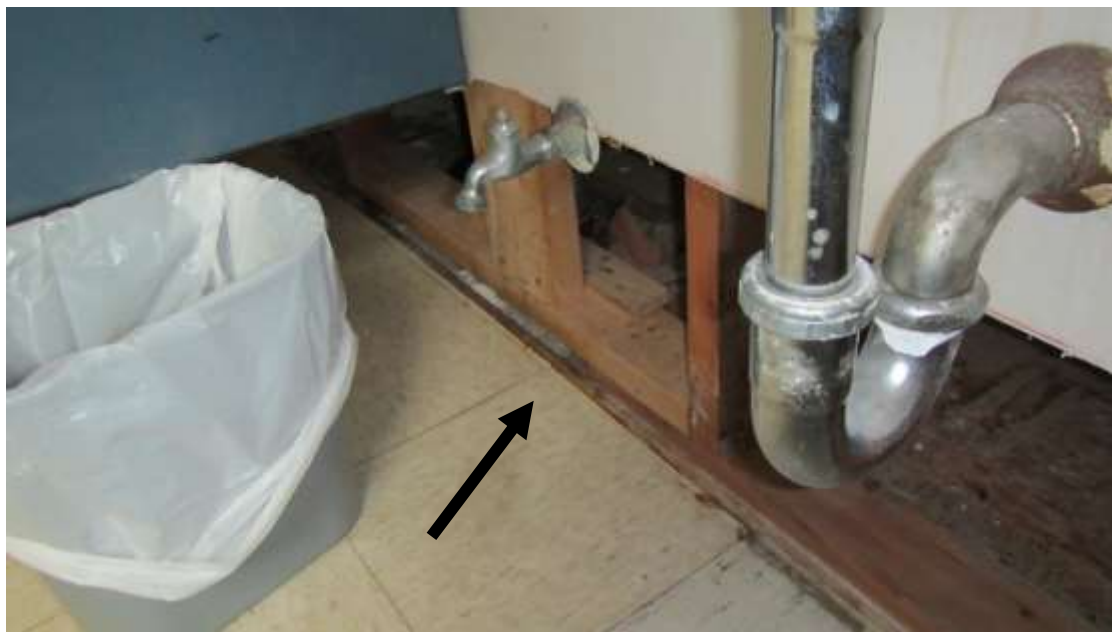
**Picture 2**

**Open seam on floor edge, note lifting tile likely from water exposure**

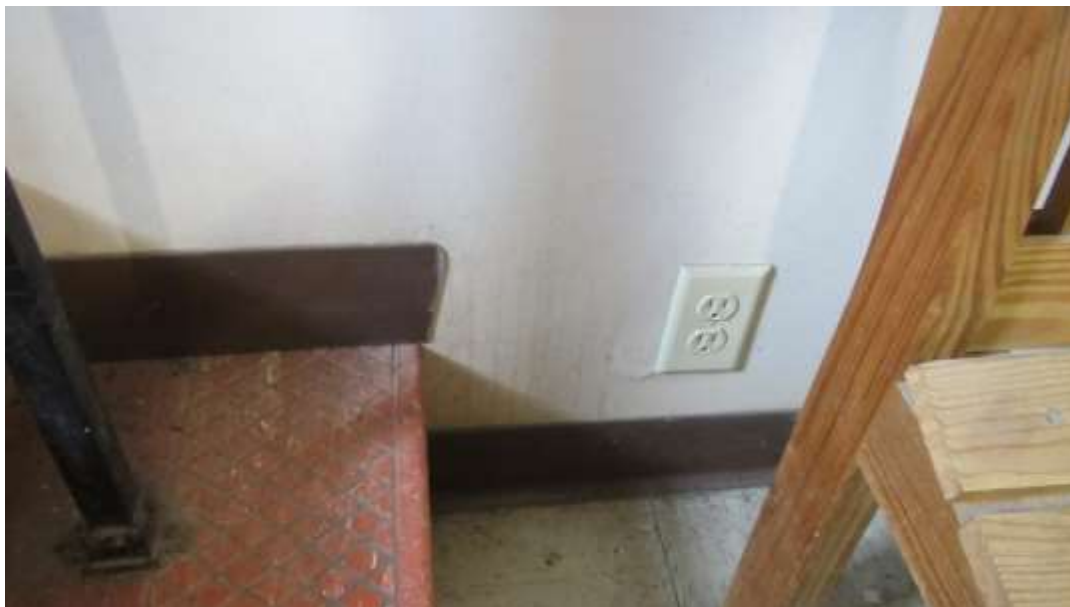
**Picture 3**

**Wall outside restroom made of GW with plastic coving**

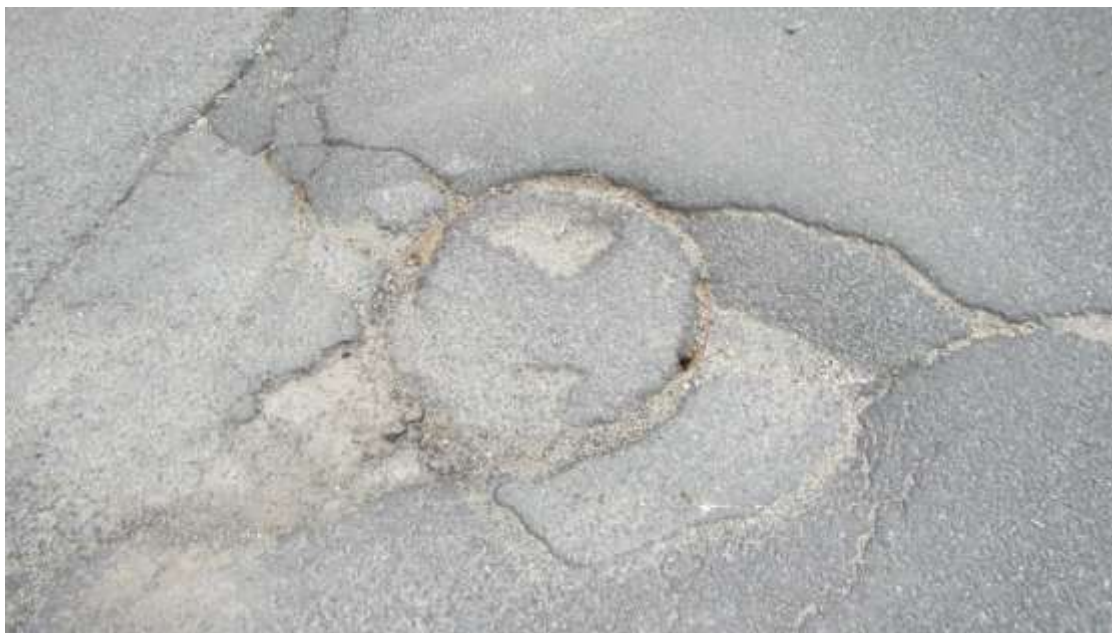
**Picture 4**

**Possible sewer manhole cover, likely not accessed since covered with tarmac**
