Analysis of Brownfields Cleanup Alternatives

MassDEP RTN 1-11501

Former Dalton Hardwood North Street Dalton, Massachusetts

Town of Dalton
462 Main Street
Dalton, Massachusetts 01226

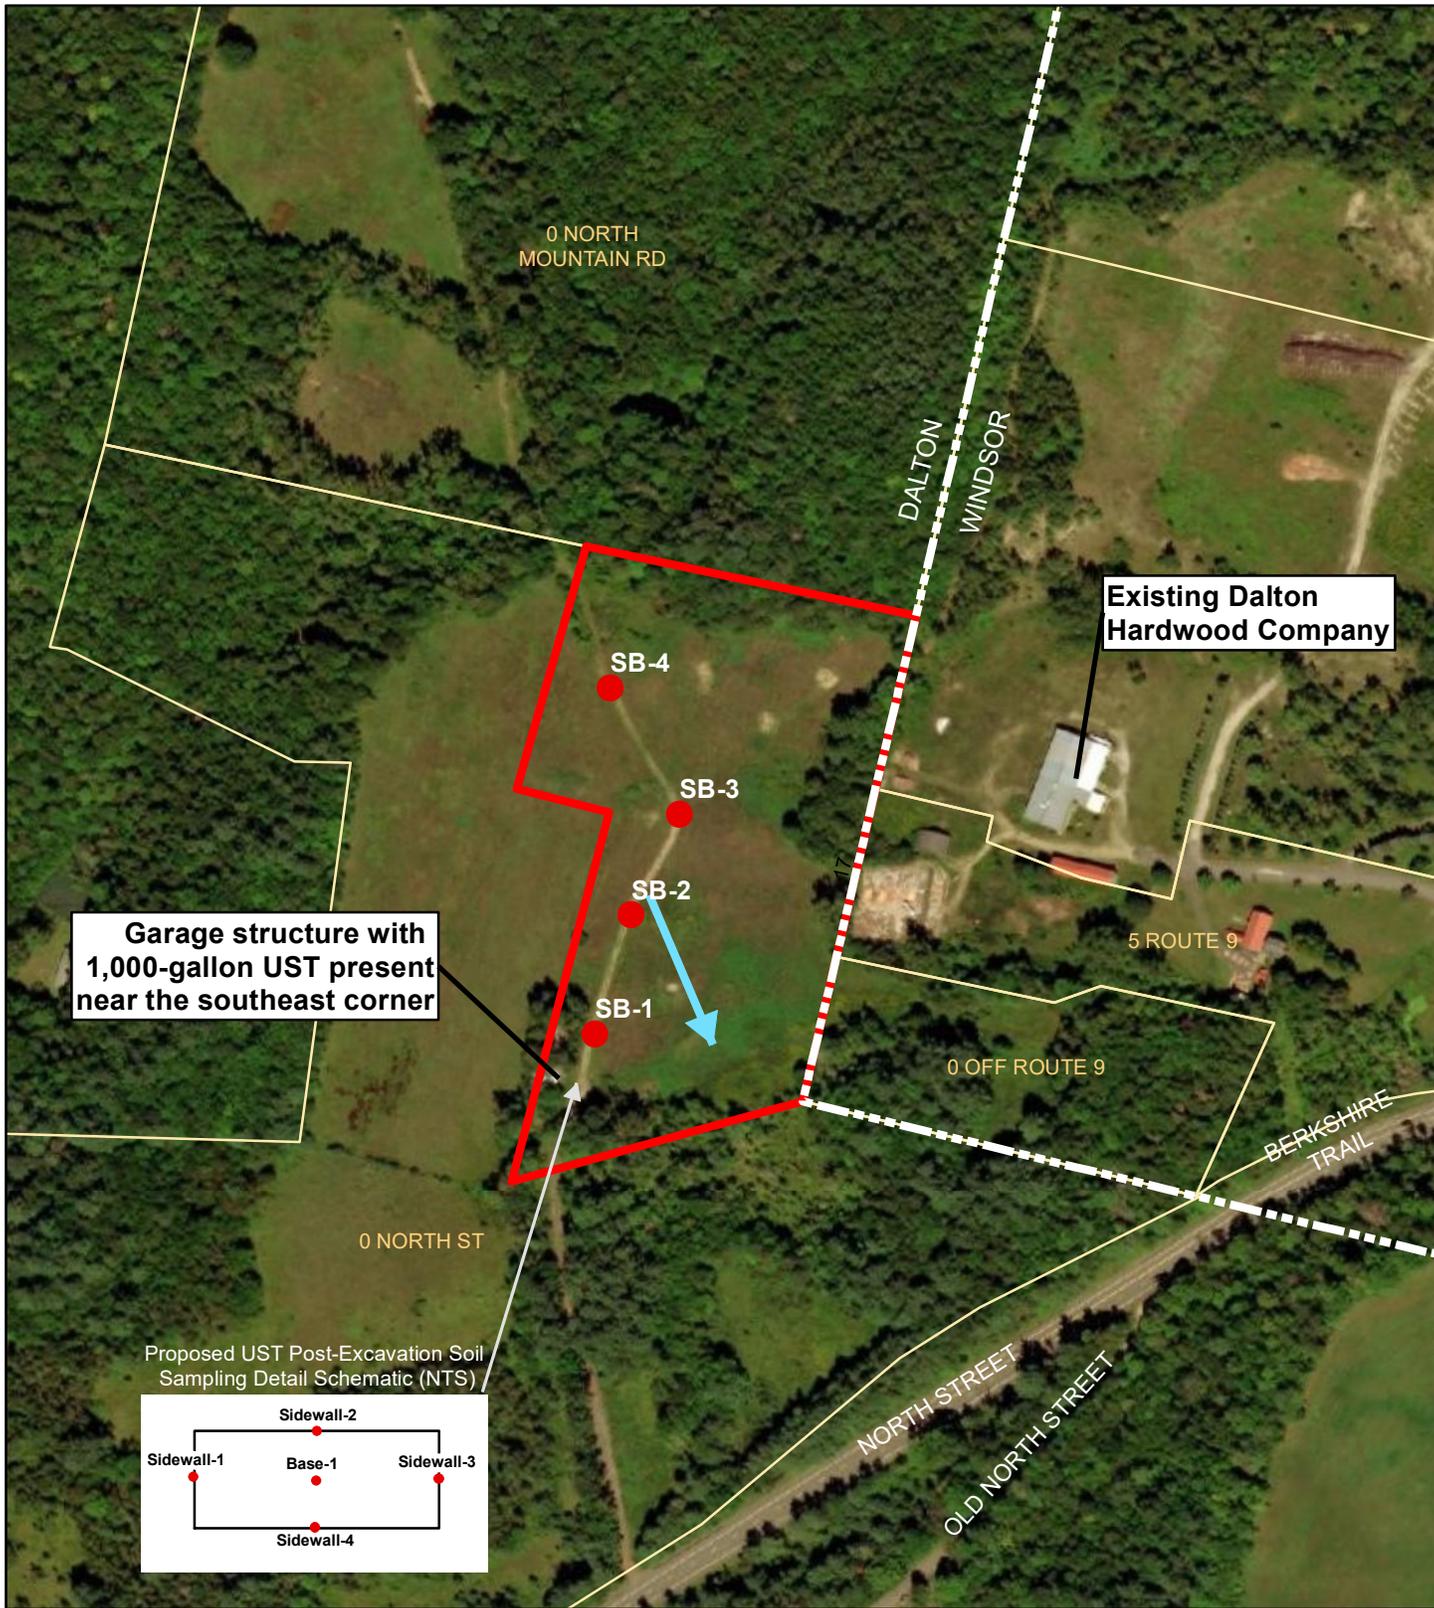
- Soil Boring Location
- Site Boundary
- ← Approximate Direction of Groundwater Flow
- Adjoining parcels

UST - Underground storage tank
 NTS - Not to scale

A Site Location Map is provided as Figure 1 and a Site Plan is provided as Figure 2.
