Re: Walker Brook Preliminary Engineering Study (Flood Mitigation) –

Preliminary Design Drawings (25% Design) and Basis of Design

Re: Geomorphic assessment of flood hazards on Walker Brook in Dalton, MA

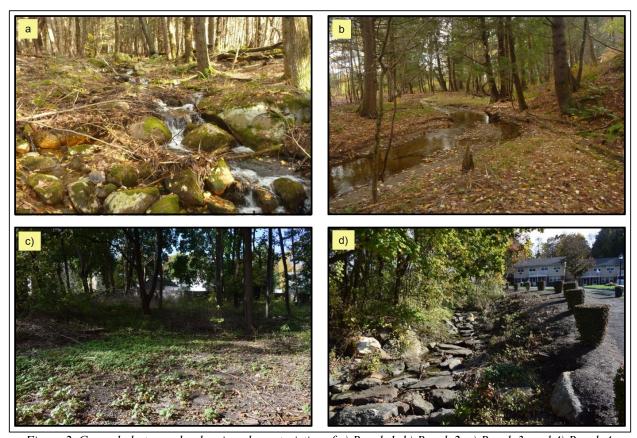
Figure 2. Ground photographs showing characteristics of a) Reach 1, b) Reach 2, c) Reach 3, and 4) Reach 4.

the steep confined channel flowing down the steep forested mountain side until reaching the base of slope. The surface is covered with large boulders near the downstream end of the reach where a visual inspection was undertaken (Figure 2a). The soils map confirms the presence of an extremely stony sandy loam (loam = a mixture of sand, silt, and clay) on the steep mountain slope derived from glacial till that is draped over the underlying bedrock (Web citation 1). No significant changes in channel position are evident when comparing historical aerial photographs and topographic maps extending back to 1947 (Appendix 2 and Web citation 2) nor are such changes expected in the future given the confined bouldery reach.

Reach 2, extending from the mountain front to High Street, has a relatively gentle gradient compared to Reach 1 and is an unconfined sinuous, sometimes multi-threaded, channel with a forested buffer (Figure 2b). Large wood and a small beaver dam were also observed in the The upper portion of the reach passes through an area of active gravel pits with the channel flowing through ponded and wetland areas formed in former gravel pits and other disturbed land. To what extent wetlands may have existed naturally in the area, if at all, is As measured through a topographic survey just upstream of High Street, the floodplain is approximately 300 ft wide, and the bankfull channel width (averaged from three cross sections) is 18.5 ft, whereas the width of the High Street culvert is only 5.7 ft (Appendix 3). The High Street road grade blocks the floodplain and constricts the channel's width by more than 50 percent (Figure 3). The channel's position in the upper portion of the reach has been greatly altered in the past as the location of active gravel pits has shifted from time to time (Appendix 2 and Web citation 2). While the channel's position at the downstream end of the reach has not

Reach 4 is in a daylighted channel downstream of Main Street and ends at Walker Brook's confluence of the East Branch Housatonic River. Purposefully placed boulders line the banks and bed of the channel for nearly the entire length of the reach (Figure 2d). The channel takes a sharp turn exiting the culvert and flows against a high forested bank (the right bank looking downstream) for most of the reach. The trees on the slope are going straight and no signs of bank instability were observed. However, a small log jam is present about half way through the reach (Figure 4) that crosses the entire channel with a bankfull width of 21 ft (Appendix 3). The channel currently flows along the edge of an alluvial fan (i.e., inland delta) formed as sediment spread out radially as Walker Brook entered the less confining East Branch valley with much of the landform likely created shortly after deglaciation when abundant sediment was likely supplied to Walker Brook. The current channel underwent a significant realignment at some point before publication of the 1876 Beers Atlas (Appendix 2). Prior to this time the channel flowed more or less straight into the East Branch just to the east of the Senior Center (Web citation 2 – see 1893 topo showing an older channel alignment) as opposed to presently flowing around the northern and western side of the facility. The Senior Center opened in 2011 in renovated facilities that were part of the West & Glennon's woolen mill first opened in 1865, was rebuilt after a fire in 1875, and underwent some changes in 1884 (Web citation 3). Given the timing, the change in channel alignment would appear associated with operation of the woolen mill.

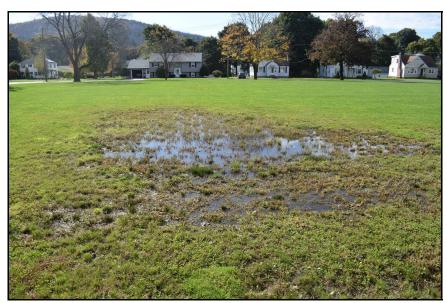
Figure 5. Persistently wet area in Town-owned field near the former school building.

Reach 3 experiences periodic flood inundation when the backwatering upstream of High Street becomes so severe that flow overtops High Street and spills into the Town-owned field downstream, creating flood impacts at the Senior Center and previously the school that used to be in the field. The adjacent homes are more elevated so less prone to flooding problems. A portion of the field near where the school building once stood is persistently wet (Figure 5) and may reflect leaking from the underlying culvert that was reported rusted in places during the 1981 inspection. Depending on the nature of the soil and artificial fill at this location, the leaking could potentially cause underground erosion (i.e., piping) that could lead to the collapse of the overlying soil and creation of sinkholes above the culvert. However, no surficial signs of piping were observed.

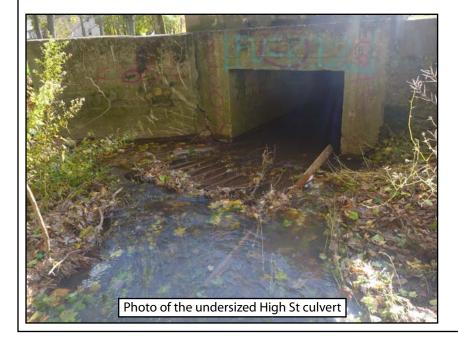
Longitudinal profile of Walker Brook upstream of High St.

\*Note: surveyed channel cross section located 94 feet upstream of culvert inlet

--- Bankfull elevation

Note: no water in stream at time of survey
